## TUOLUMNE COUNTY BEHAVIORAL HEALTH

Update to the Mental Health Services Act (MHSA)  
FY 2013/2014 Annual Update -  
**For the Purpose of Assigning/Transferring Unspent  
Community Services and Supports (CSS) Funds for  
General Systems Development (GSD) Housing**

# Building Inspection Report

Report Number: 54155  
Structure Type: Multi Family Res  
Approx. Sq. Ft.: 2884  
Approx. Year Built: 1982  
Weather Conditions: Dry  
Temperature: 60degrees  
Inspection Time: 9:00am  
Client Present: No  
Real Estate Agent Present: No  
Inspection Type: Visual

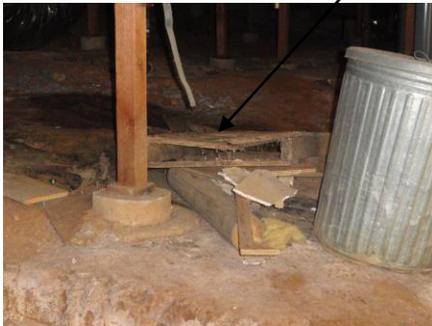
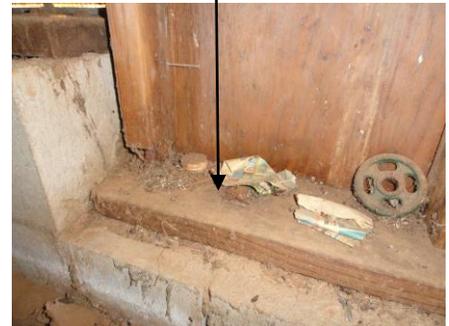
- **Improve:** All wood debris and/or trash should be removed from the crawl space and the sill plates need cleaning. Organic debris around a property increases risk of insect or rot damage.

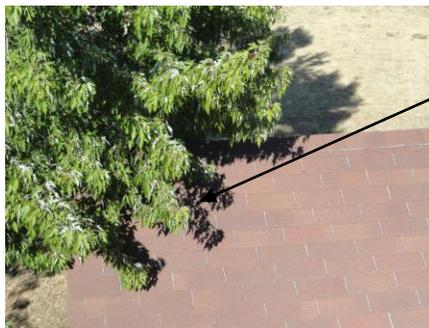
**Deferred Cost:** Shed roof will need replacing in about 5 years.

Tree branches need to be trimmed away from the roof on the shed

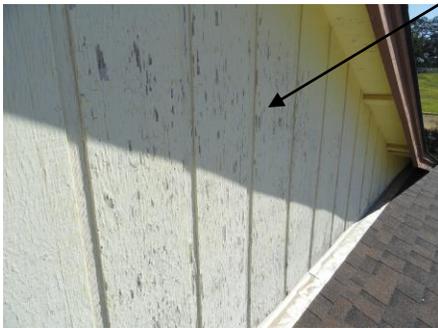
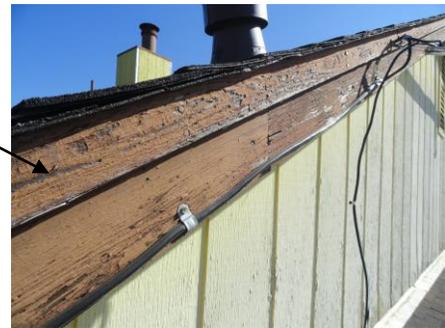
- **Improve:** The wood siding should be painted to preserve the building.

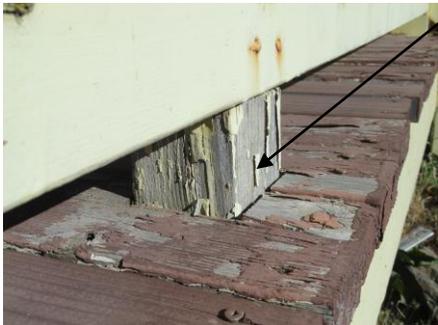
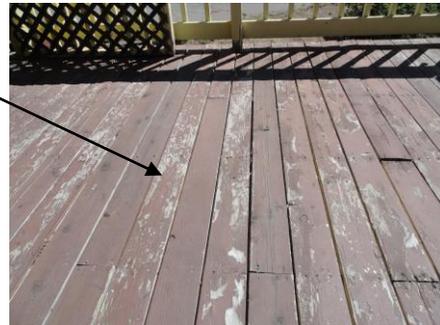
- **Improve:** The wood decking should be painted or stained to prevent deterioration.

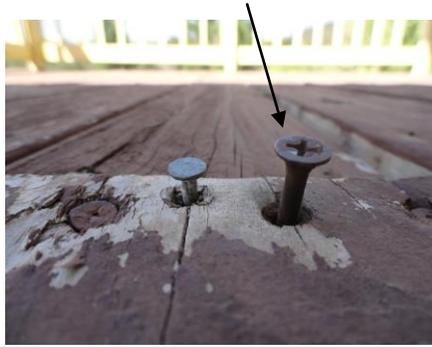
- **Safety Issue:** Deck nails and screws are protruding up and causing a trip hazard.

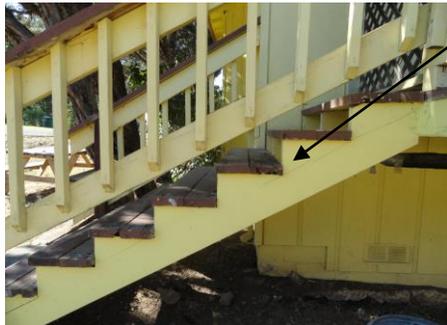
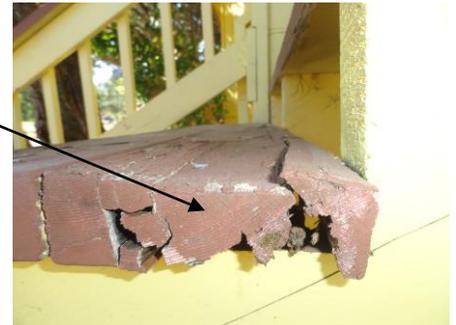
- **Repair, Safety Issue:** The deck steps are rotting on the north side (steps # 6 & 7) and should be replaced as they are unsafe.

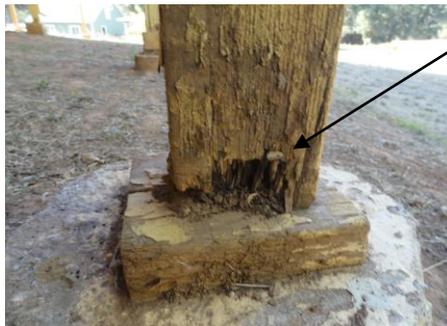
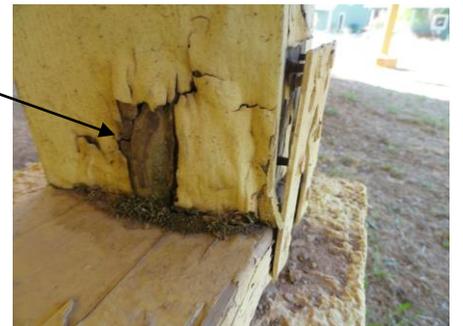
- **Repair:** Some deck posts shows evidence of rot. Replacement or repair may eventually be desired.

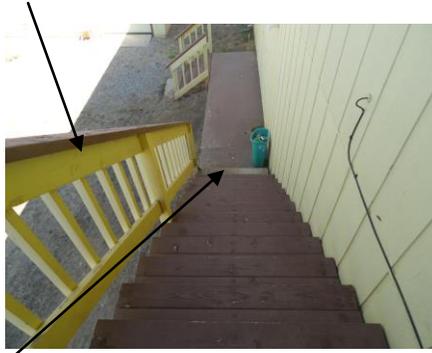
- **Safety Issue:** There is no handrail installed on both set of stairs.

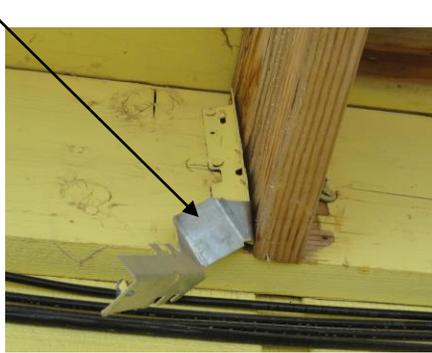
- **Safety Issue:** The bottom 2 steps on the back stairs are not of equal riser height or tread depth. This is a trip hazard.
- **Repair:** A deck joist hanger is not attached properly on the south side.

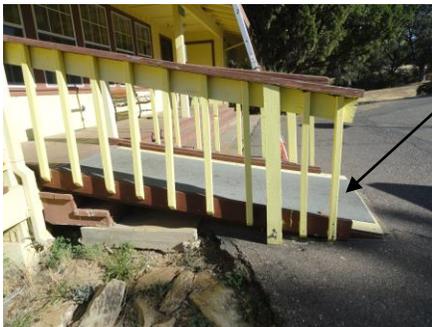
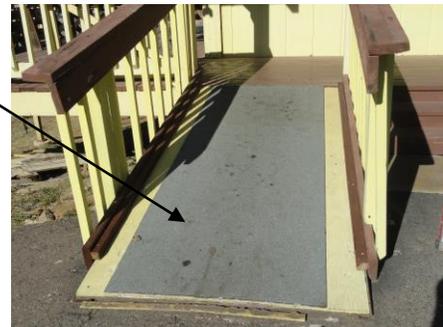
- **Safety Issue:** The ramp in the front is not ADA compliant as it is too steep of a slope.

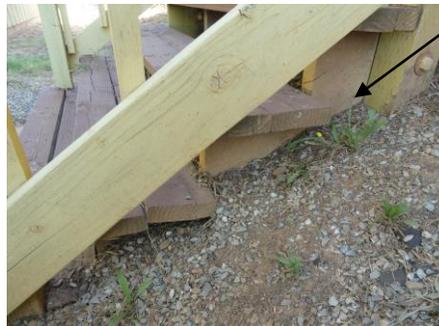
- **Repair:** There is earth to wood contact at the west stairs. This will create a condition for rot to take place.

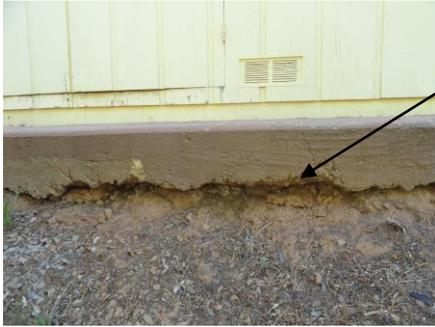
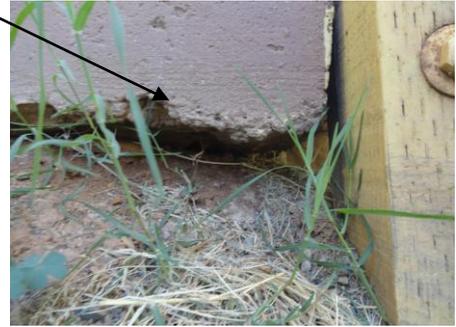
- **Improve:** The concrete slab in the back is becoming undermined. Soil under it is being washed away. This can cause the concrete to crack and move.

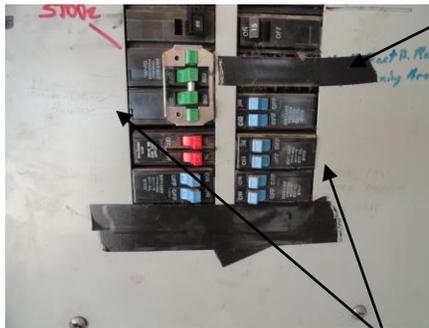
- **Safety Issue:** Any openings in the main panel should be covered by approved plugs & not tape.

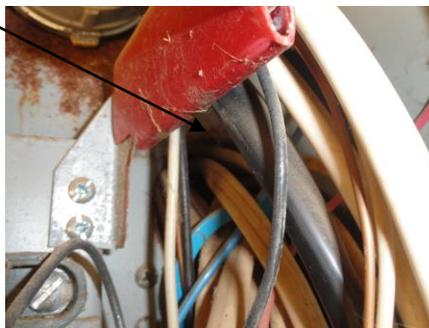
- **Safety Issue:** The cover around the breakers needs to be clearly labeled. Some are and some aren't.
- **Improve:** The grommet is missing where the branch wires enter the service panel.

Hard to see but the grommet is missing in the back of the service panel.

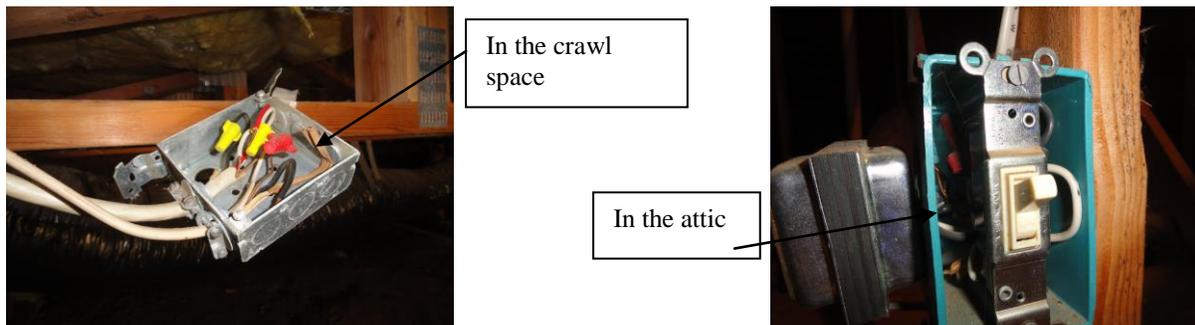
- **Safety Issue:** All junction boxes and switches should be fitted with cover plates, in order to protect the wire connections. A splice box in the crawl space has no cover plate and is not mounted properly.

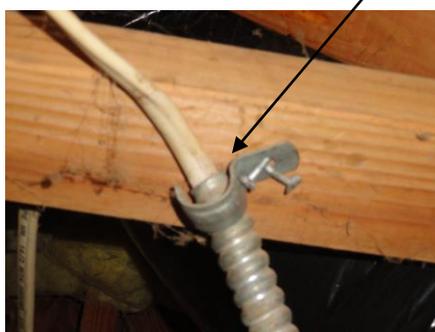
- **Safety Issue:** Romex wiring entering flex metal conduit with sharp edge at small water heater in crawl space.

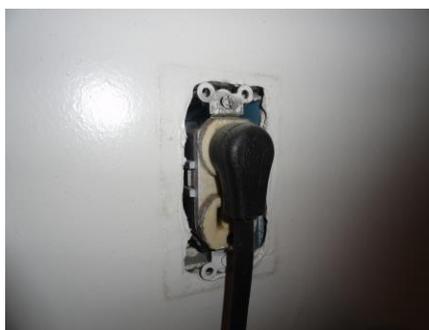
- **Safety Issue:** Missing outlet cover plates should be replaced to avoid a shock hazard.

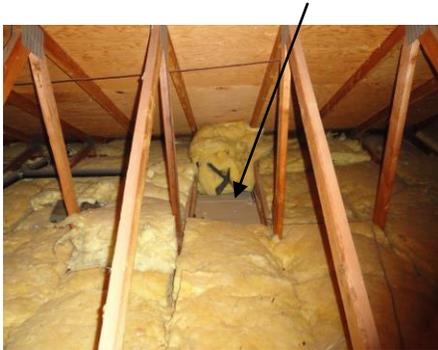
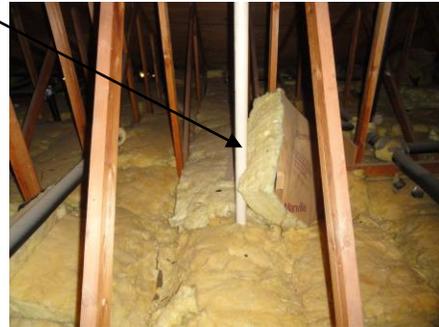
- **Improve:** Disturbed insulation should be repaired or evened out.

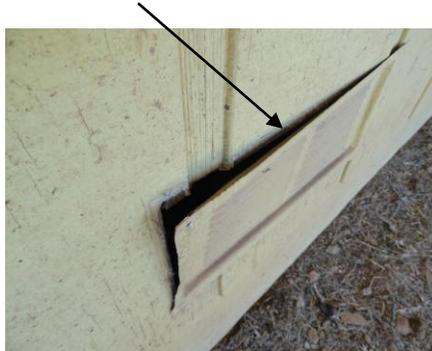
- **Repair:** A foundation vent is coming loose on the south side. This can allow vermin to enter the crawl space.

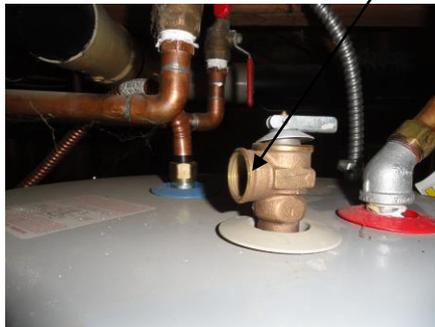
- **Repair, Safety Issue:** For safety reasons, it is recommended that a Temperature and Pressure Relief (TPR) Valve be properly installed for the main water heater and terminate to the exterior. Recommend a licensed plumber to repair this .

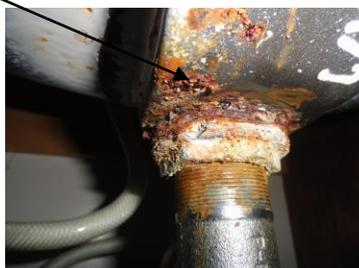
- **Improve:** The bar sink in the kitchen was observed to drain slowly, suggesting that an obstruction may exist.
- **Monitor:** The sink is rusting underneath bathroom #3

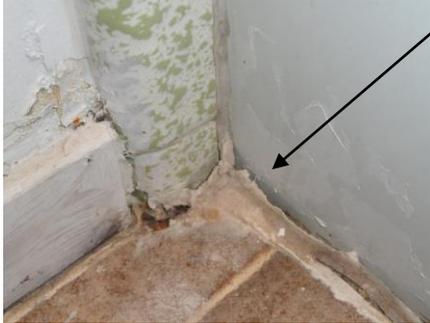
- **Repair:** Evidence of water damage to the floor adjacent to the bathtub enclosure was observed in bathroom #3. The extent of damage is difficult to predict without removing floor coverings.

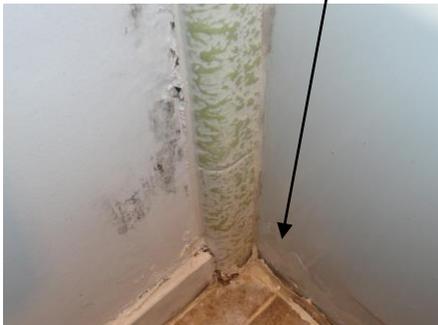
- **Improve:** It is recommended that an anti-siphon device be added to the hose bib(s). The anti-siphon device serves to prevent chemicals from getting into the house water supply when mixing chemicals for exterior landscaping. Please visit <http://www.berryhilldrip.com/Backflow.htm>
- **Improve:** Bathtub caulking at the floor needs to be replaced in bathroom #1,2 & 5

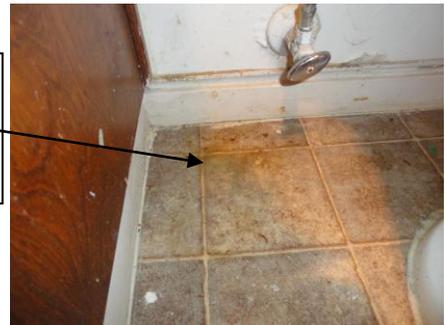
Water on floor in # 5. From splashing at the sink above.

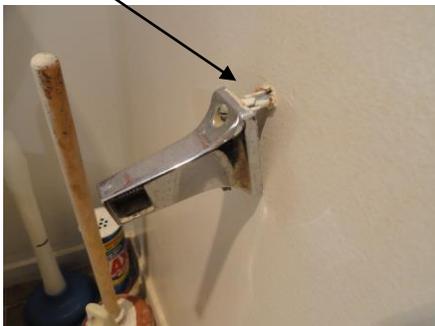
- **Improve:** Sink stopper missing in bathroom #1.
- **Improve:** Toilet caulk at the floor needs replacing in bathroom # 2
- **Repair:** Toilet paper holder is broken in bathroom # 2

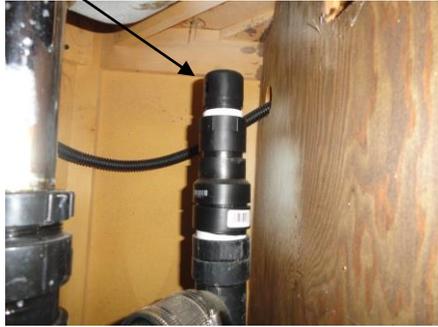
- **Monitor:** The presence of air admittance vent under the kitchen sink. These can fail at any time.

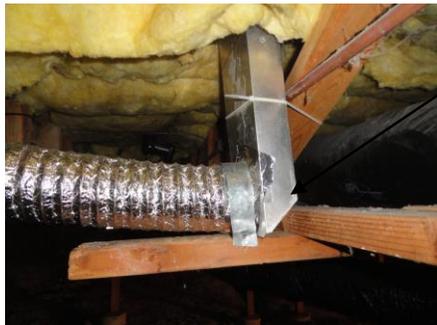
- **Improve:** The clothes dryer exhaust vent pipe should be improved, recommend replacing with smooth metal pipe to avoid lint build up.

This type of set up tends to clog up in this area.

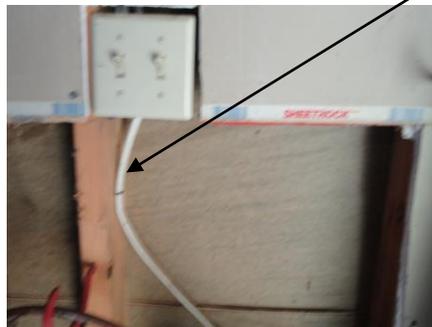
- **Safety Issue:** A wire on the right side under the plug is supposed to be protected with sheetrock or conduit in the shed.

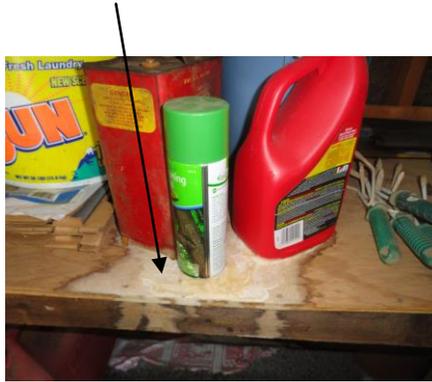
- **Safety Issue:** There are corrosive materials leaking on a shelf in the shed. Recommend this be disposed of in an approved manner.

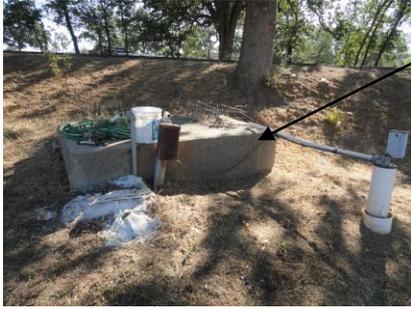
Septic tank access  
cover in front of  
house. Safe???

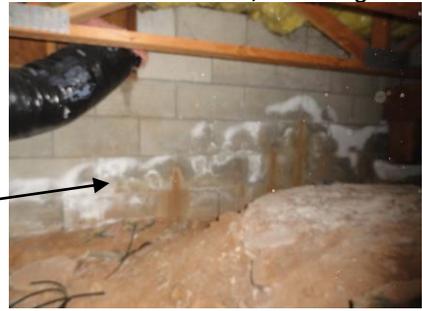
Efflorescence from past moisture at the foundation.
