## TUOLUMNE COUNTY BEHAVIORAL HEALTH

Update to the Mental Health Services Act (MHSA)  
FY 2013/2014 Annual Update -  
**For the Purpose of Assigning/Transferring Unspent  
Community Services and Supports (CSS) Funds for  
General Systems Development (GSD) Housing**

# Building Inspection Report

Report Number: 54155  
Structure Type: Multi Family Res  
Approx. Sq. Ft.: 2884  
Approx. Year Built: 1982  
Weather Conditions: Dry  
Temperature: 60degrees  
Inspection Time: 9:00am  
Client Present: No  
Real Estate Agent Present: No  
Inspection Type: Visual

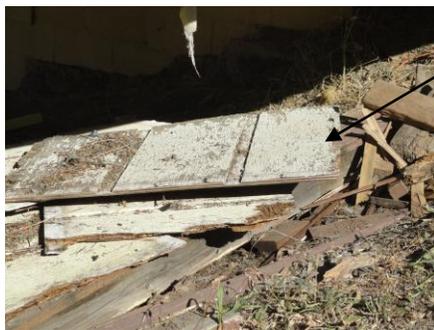
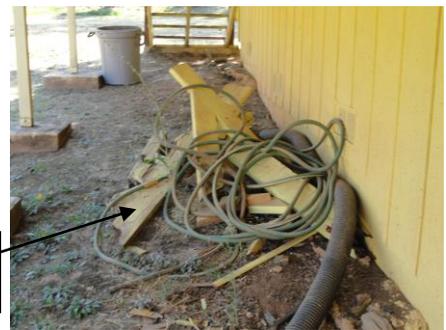
Under deck south side

- **Improve:** There is a lot of wood debris under the south and north deck. This is a nice place for snakes and scorpions to nest.

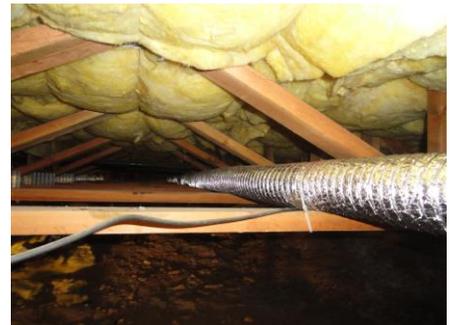
This type of set up tends to clog up in this area.

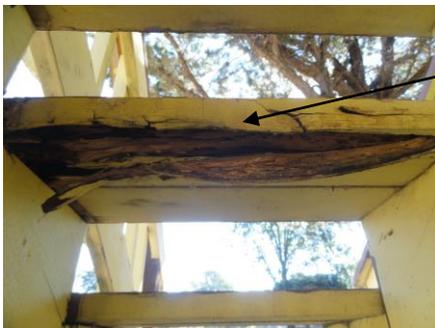
Rotted stair tread  
North side
